## Inspection Report

**John Doe**  
**Property Address:**  
**6555 Any Street, Atlanta Metro**  
**Any Town Ga. 30097**

Sample Report

Georgia State Inspections  
Jake Accardi ICC 8034454- B2  
[www.gastateinspections.com](http://www.gastateinspections.com)  
404.514.7457  
[jaccardi@gastateinspections.com](mailto:jaccardi@gastateinspections.com)

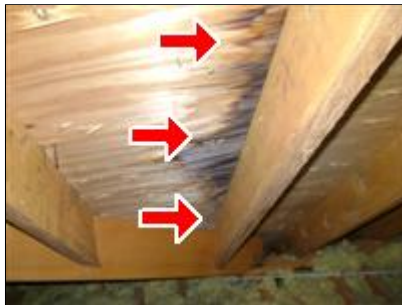
1.0 Picture 1 water stains

Valley on roof allowed water intrusion, infrared thermography as well as a Delhorst J-lite moisture meter was used to determine if leak was active.

Recommend obtain repair records if available and either monitor or have a licensed roofing contractor inspect.

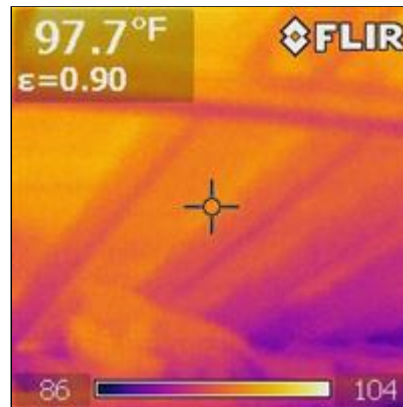
1.0 Picture 2 No active leak

Moisture meter reading was 11.5 which is acceptable and the infrared camera showed no signs of moisture present. It is my opinion that leak has been fixed.

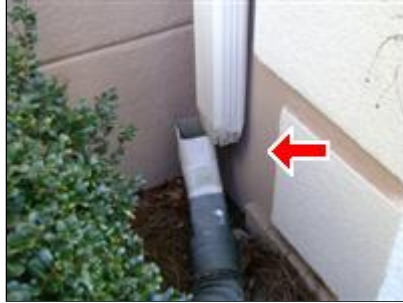
1.3 Picture 1 reattach down spout

Down spout needs to be repaired at elbow to keep water away from foundation. A simple attachment was performed by GSI. No further action is required on this item.

Down spout needs to be repaired at elbow to keep water away from foundation. A simple attachment was performed by GSI. No further action is required on this item.

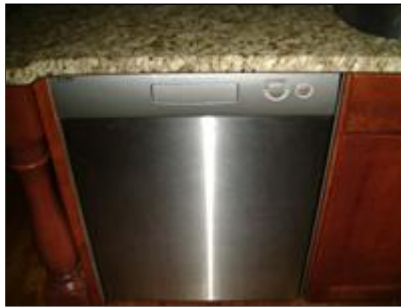
3.0 Picture 1 Serial # on actual report

ASKO Dishwasher. I recommend obtaining all user manuals and guides, if not available you can call or go to there web site.

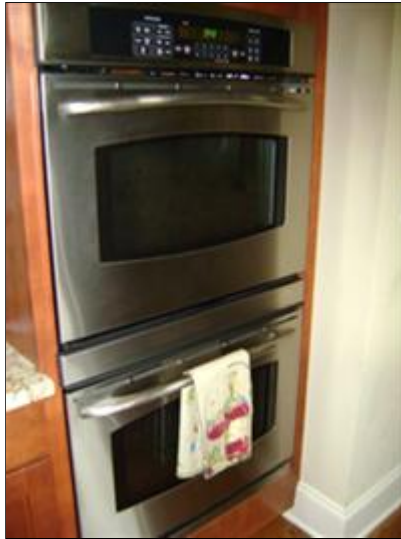
3.1 Picture 1 Actual report serial #  
provided

(1) Oven(s) functioned as intended at time of inspection. GE Profile, electric oven. I recommend obtaining all user manuals and guides, if not available you can call or go to there web site.

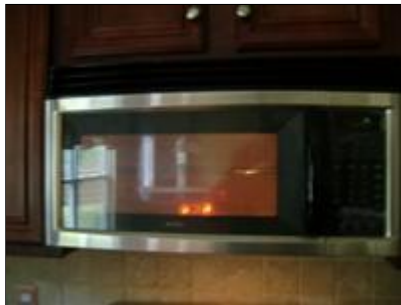
3.1 Picture 2 Microwave Test

(2) The Microwave, Light and exhaust Fan functioned as intended at time of inspection. I recommend obtaining all manufacture instruction manuals for free at.

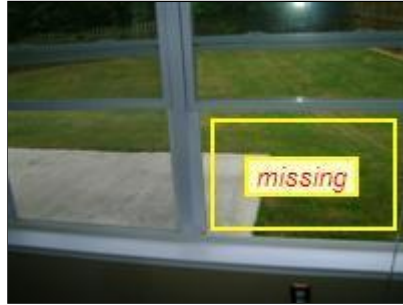
4.6 Picture 1 Screen missing

All windows were inspected and functioned as intended at time of inspection, one screen was missing at dining room window

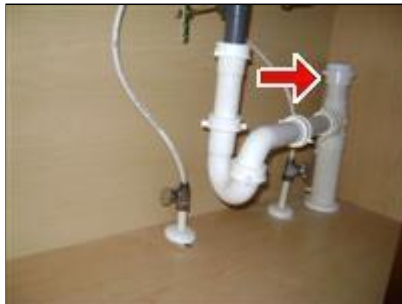
7.0 Picture 1 Studor vent

(1) Studor vents are used throughout house to vent plumbing, these vents keep to a minimum roof penetrations and are used in locations such as islands or areas that can not be tied to a roof vent. They can go bad after sometime, if egg like smell persists in room or under cabinet where a studor vent is located call a plumber to have the vent replaced.

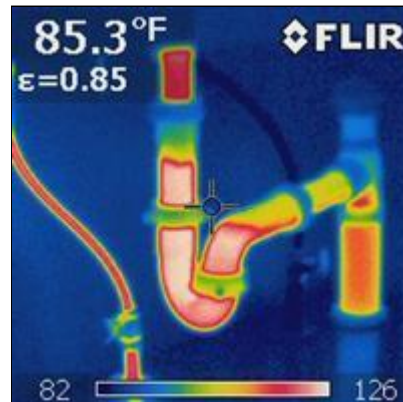
7.0 Picture 2 IR Picture

All areas under sinks, toilets (wax seals), shower diverters and jetted tub at motor were inspected using Infra red thermography, no leaks were detected at time of inspection.

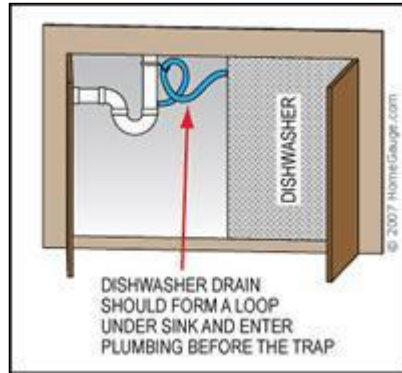
7.0 Picture 3 Drain Loop

(2) No loop in drain for dishwasher, I recommend when replacing dishwasher or during any service calls for dishwasher add loop to drain hose.

(2) No loop in drain for dishwasher, I recommend when replacing dishwasher or during any service calls for dishwasher add loop to drain hose.

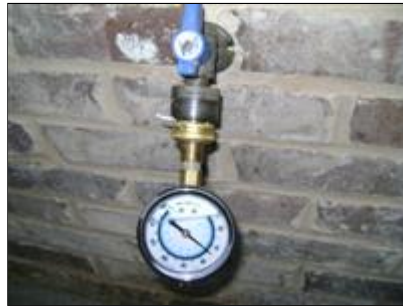
7.1 Picture 1 50 lbs. p.s.i.

Your water pressure is 50 Pounds Per Square Inch. (lbs. psi.) In a working home the water pressure should be between 40-80 Pounds (Lbs.) Per Square Inch (p.s.i.)

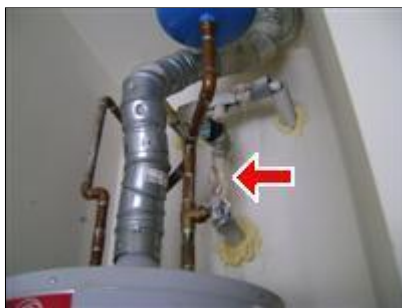
7.3 Picture 1 Shut off

Exterior main Water shut off at the street in meter box requires a meter wrench to open and close.

Interior main water shut off is located above the hot water heater in the garage, this valve is a in line shut off plastic valve and does not need a wrench.

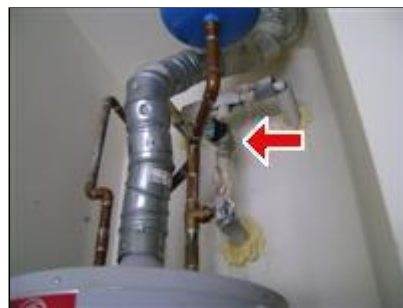
7.3 Picture 2 PRV

Pressure reducing valve (PRV) is located in the same location above the shut off.

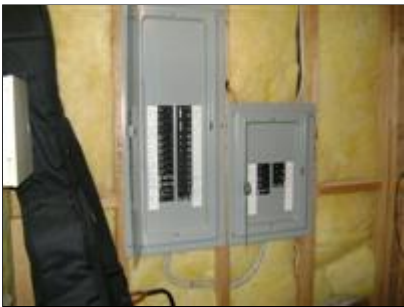
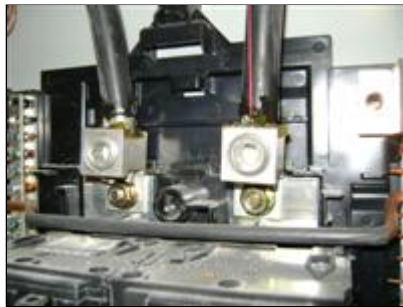
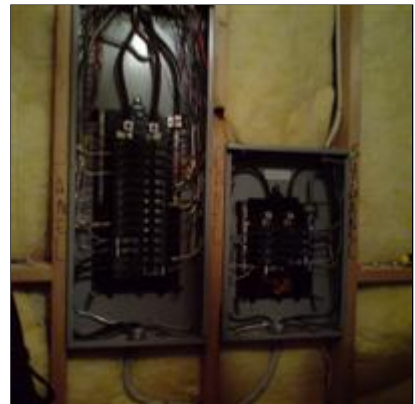
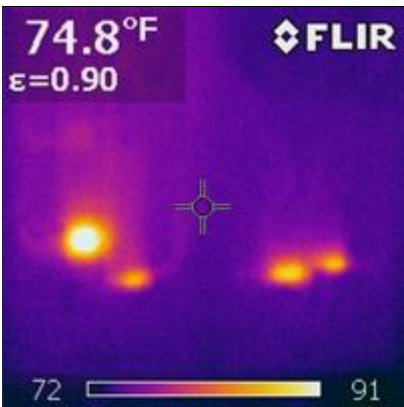
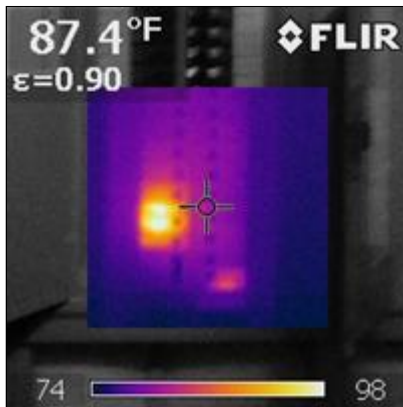
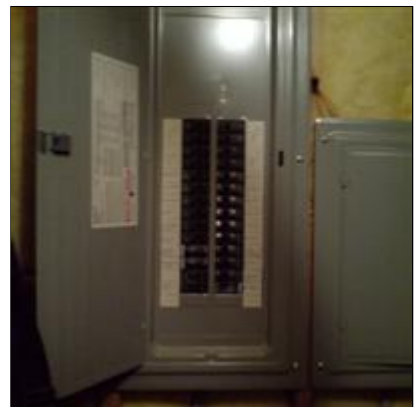
(1) Inspected inside of Panel boxes, everything appeared to be functioning as intended. Infrared inspection reveals GFCI and AFCI breakers which is normal.

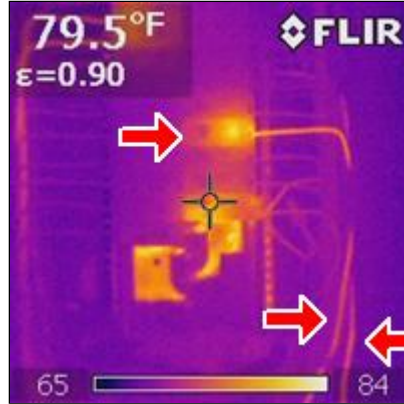
9.1 Picture 7 undersized breaker

(2) Hot Breaker and Wiring, I recommend a qualified electrical Contractor repair or replace undersized breaker and or wiring.

(2) Hot Breaker and Wiring, I recommend a qualified electrical Contractor repair or replace undersized breaker and or wiring.

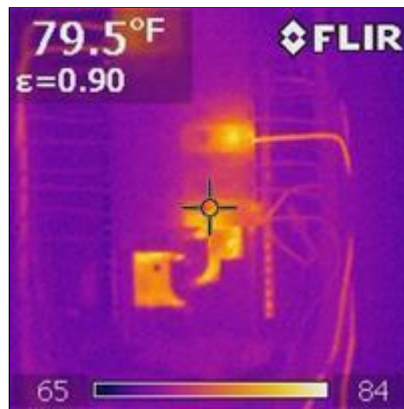
9.1 Picture 8 Undersized Breaker

(3) Undersized Breaker / Wire, I recommend a Licensed Electrical contractor inspect repair and replace as needed. This is a safety issue.

(3) Undersized Breaker / Wire, I recommend a Licensed Electrical contractor inspect repair and replace as needed. This is a safety issue.

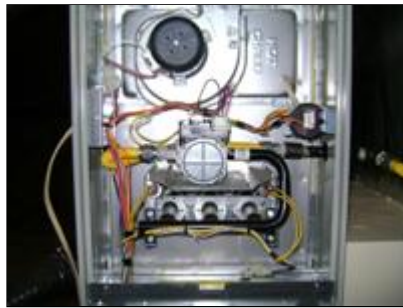
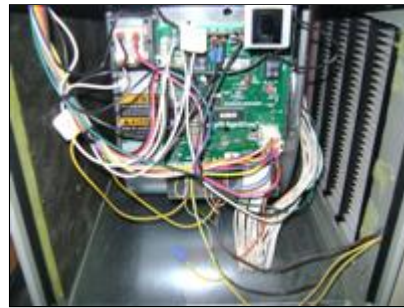
11.0 Picture 1 Furnace

Furnace located in attic. All Gas Lines will Be inspected and shut offs located.

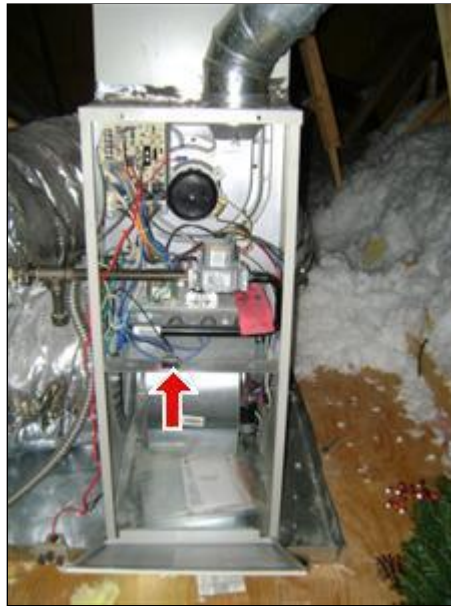
11.3 Picture 1 auto shut off switch

The safety switch did shut off unit when service door was removed.

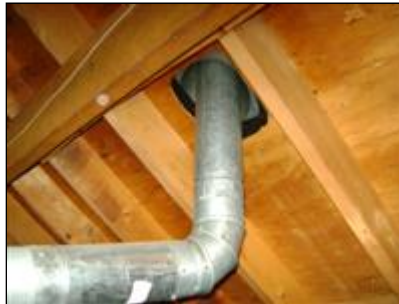
11.4 Picture 1

Furnace exhaust vent.

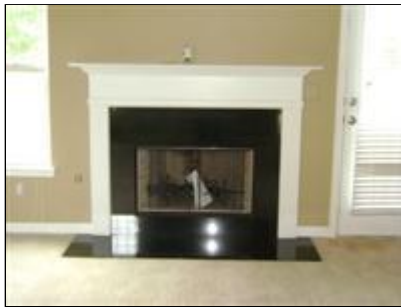
11.8 Picture 1 Fireplace

Gas exterior shut off for fireplace is on of house beside the chimney, interior gas shut off is on the left side of hearth the exterior gas valve is in the on position to check for gas leaks, none found at time of inspection, gas valve closed at completion of inspection.

**Fire Place model # GR-41 Fireplace # ak677300 Heatilator.** The fire place appears that it has only been used for gas logs and not solid fuels and it appears that it has been used only a couple of times, damper door functions as intended, flue not inspected due to accessibility, note in fire box from sellers agent preventing access. **Dead Wasps fell from flue when opening damper.** Before operating I recommend a NFPA certified chimney sweep inspect and explain to buyer the proper operating procedures and I recommend contacting manufacture at website below and obtaining all owner / operating manuals before putting the fire place in service.

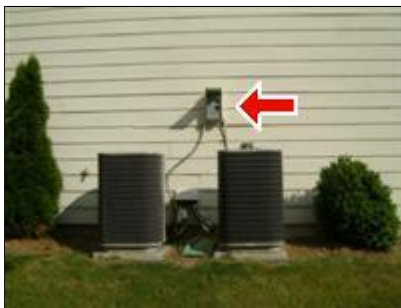
11.11 Picture 1 A/c disconnect

There are two Gibson Compressors on the left side of the house looking from the street. Downstairs model # js5bd-024k, serial # jsa060405399 2.0 Ton, Upstairs model # js5bd-024k, serial #jsa060405237 2.0 Ton I recommend obtaining all user manuals and guides, if not available you can call or go to there website
